NEWTOWN DAM, BUCKS COUNTY
PENNSYLVANIA

PHASE I INSPECTION REPORT,
NATIONAL DAM INSPECTION PROGRAM

WOODWARD-CLYDE CONSULTANTS
5120 Butler Pike
Plymouth Meeting, Pennsylvania 19462

OVERVIEW
NEWTOWN DAM (SCS PA 621), NEWTOWN TOWNSHIP, BUCKS COUNTY, PENNSYLVANIA

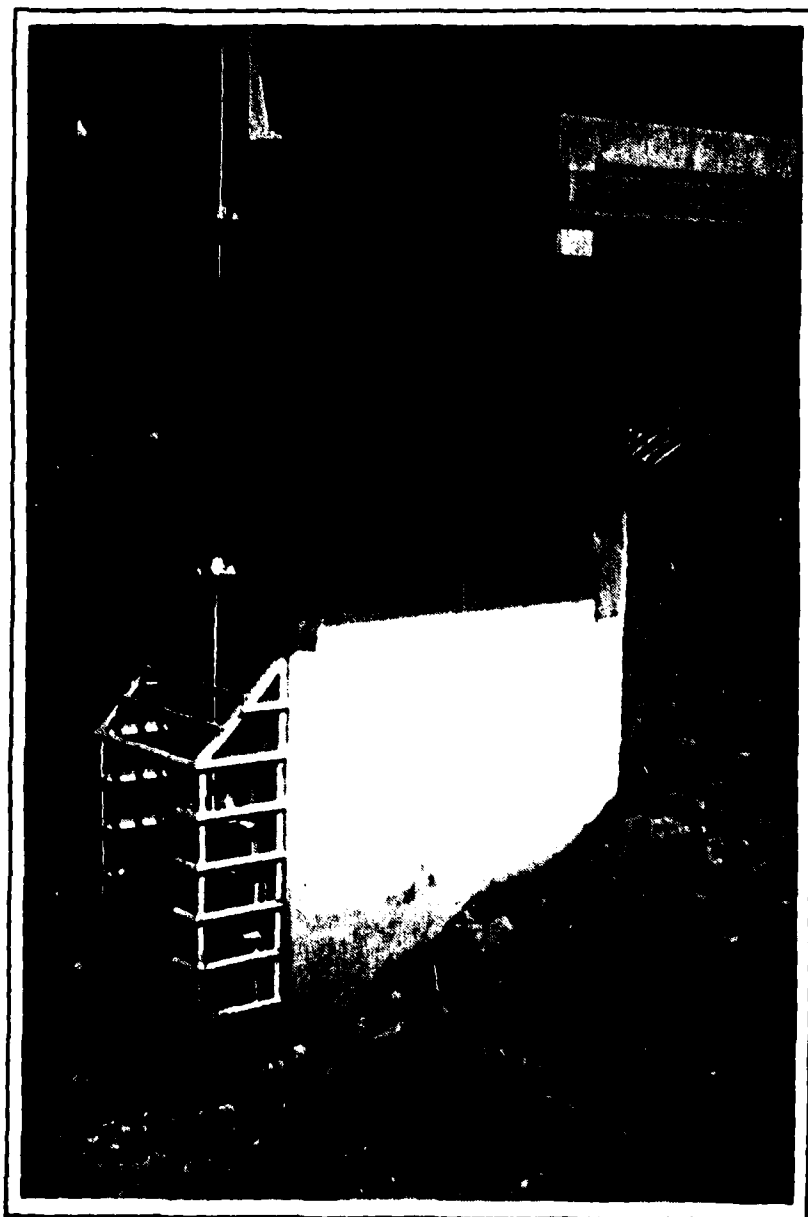
PHOTOGRAPH NO. 4

1. Principal Spillway. As shown on the plates, the riser is located at the upstream toe of the embankment. The exposed portions of the riser were inspected and evaluated to be in good condition with no signs of concrete deterioration, spalling or other structural deficiency or defects, Photograph

4. An angle in the low stage trash rack is slightly bent. The impact basin at the downstream toe was inspected and found to be in good condition, Photograph 5, with no cracking or spalling of the concrete or erosion adjacent to the structure. The embankment drains outlet through the walls of the impact basin and were dry. The downstream channel was also inspected and found to be in good condition, with no significant erosion or deterioration.

PRINCIPAL SPILLWAY RISER AT UPSTREAM
TOE.

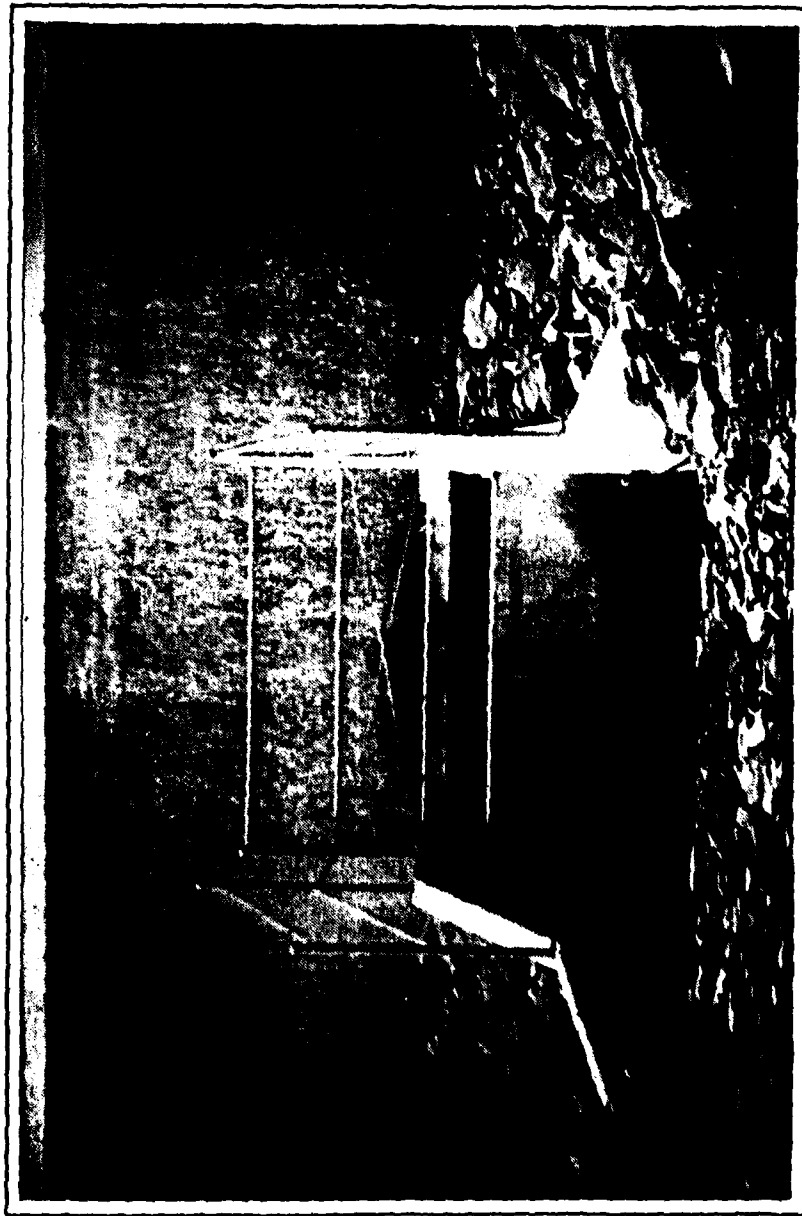
PHOTOGRAPH NO. 5

IMPACT BASIN AT DOWNSTREAM TOE.

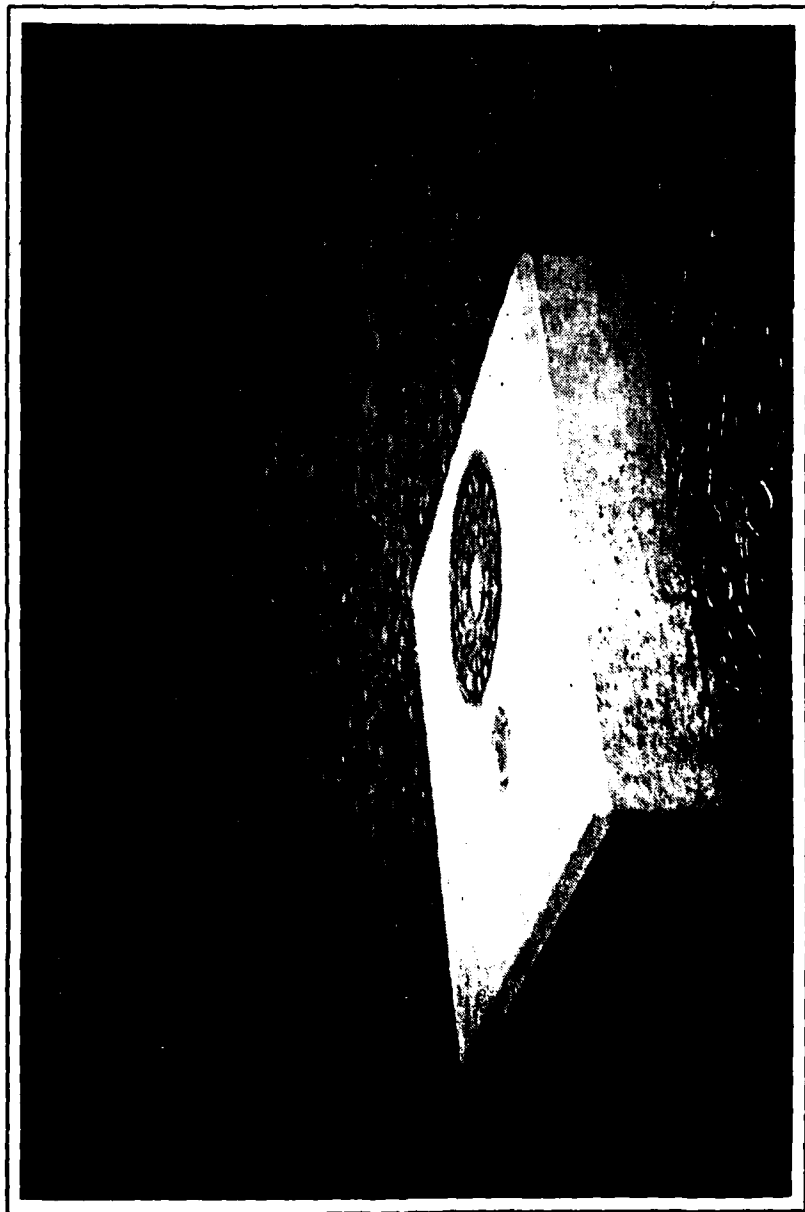
PHOTOGRAPH NO. 9

SANITARY SEWER MANHOLE. SEWER IS
UNDER EMBANKMENT.
